Forest Service
U.S. DEPARTMENT OF AGRICULTURE

Pacific Southwest Region | September 2023

**ESF4 Burned Area Emergency Response Assessment
Technical Report
Hawaii Wildfires (CA-FE9-000005)
September 11, 2023**

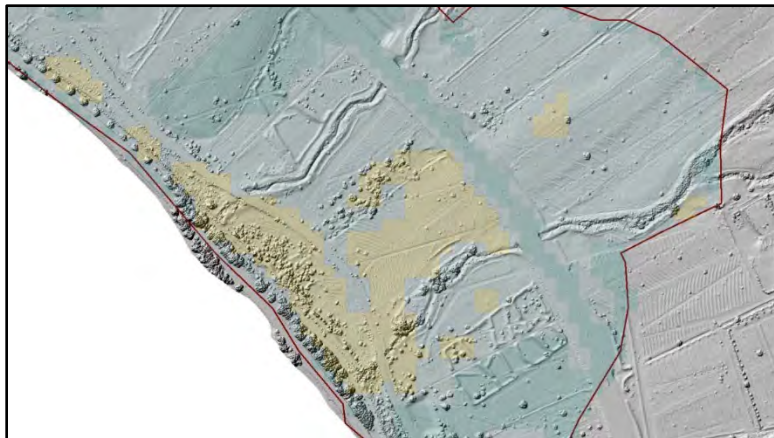
Figure 1. South Lahaina burn area. Berms line the main drainage, disconnecting surface flow from the lower slopes from the main channel. Other berms along roads and property boundaries also create storage depressions that trap runoff.

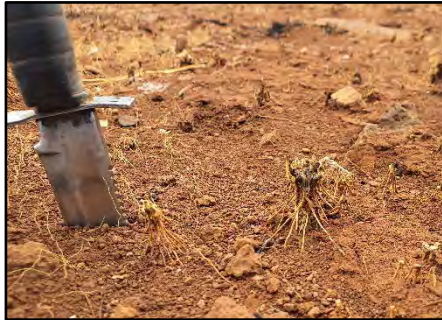
Picture 7. Evidence of post-fire wind erosion on the Lahaina Fire (USDA FS)

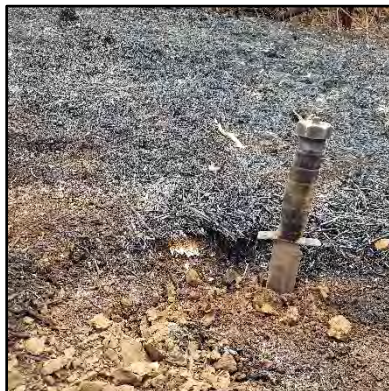
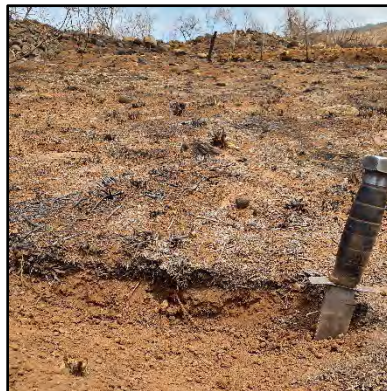
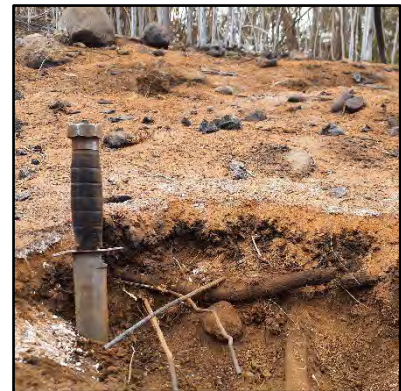
Picture 8. Photos of the three classes of soil burn severity. On the left, low soil burn severity in the Lahaina Fire. In the center, moderate soil burn severity in the Lahaina Fire. On the right, high soil burn severity in the Kula Fire. (USDA FS)

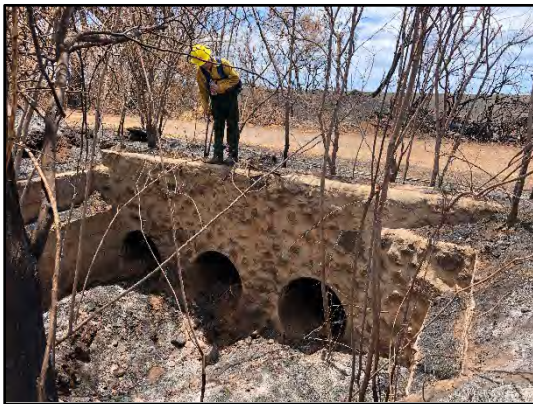
Picture 9. BAER team member assessing culvert condition in the Lahaina Fire (USDA FS)

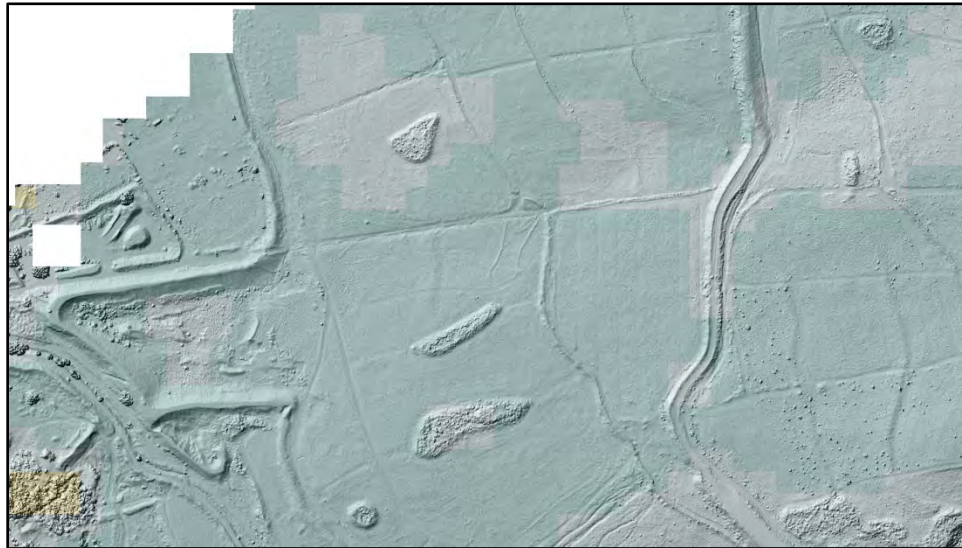
Figure 5. Central Lahaina burn area. Multiple berms are visible in the vegetated uplands surrounding Lahaina. A sediment basin/wetland and berm system hydrologically disconnect the uplands from the built environment.

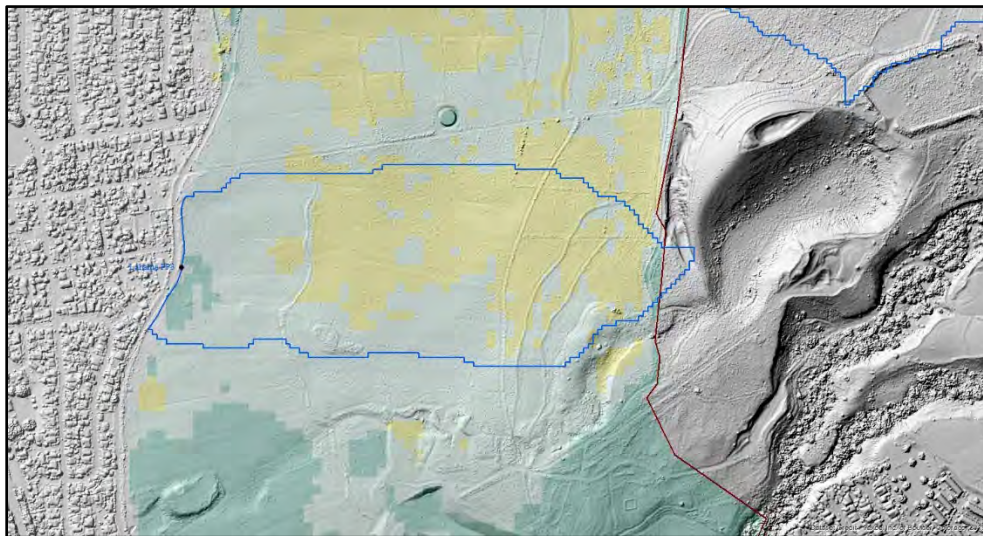
One or two catchments draining each fire were evaluated (Appendix A-F. Map Products). Catchments were generally selected with outlets at critical values (typically a major road/stream crossing or the ocean). Selected catchments were generally those of the largest streams draining the burned areas. In many cases, the area burned in these catchments was relatively small. The estimates suggest a minor increase in runoff due to burned conditions, except for the small drainage on the north end of the Lahaina Fire (Table 4). Elevated runoff response at the hillslope and small-catchment scale within burned areas is likely to be greater than at the scale of the evaluated watersheds, as results in the 113-acre *Lahaina 3* catchment indicate. However, these smaller-scale effects will generally be diminished in the flow volumes of the larger streams. Critical values immediately downstream of smaller, more extensively burned catchments (such as *Lahaina 3*) are likely at higher risk of damage from elevated post-fire runoff during intense rainstorms. Extensive drainage modification in the *Lahaina 3* catchment

Figure 6. Lidar imagery of the Lahaina 3 catchment illustrating the landscape alterations

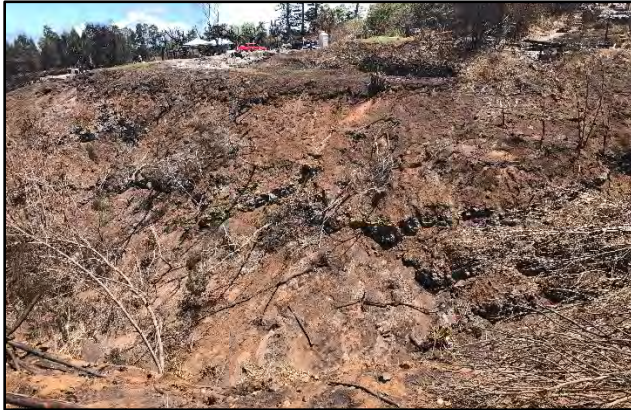
Although the burned areas are not likely to generate a large debris flow, other slope instability such as shallow landslides, slumps, and rockfall are expected to increase in the Kula and Olinda burned areas. Interbedded lava flow layers exposed in the gulch walls have varying levels of erosion resistance with

Picture 10. Slope instability observed in the Kula Fire (USDA FS)

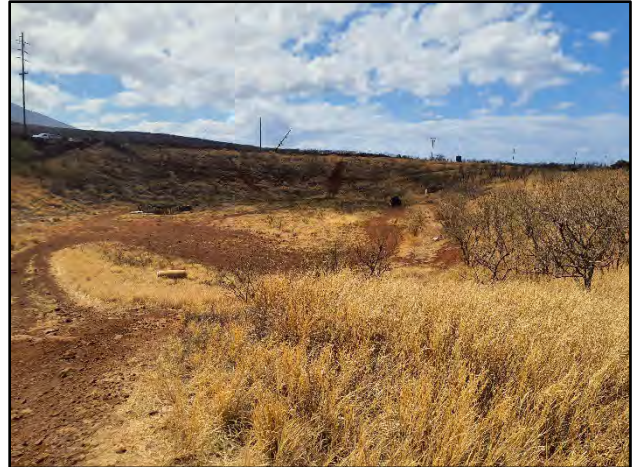
The area surrounding Lahaina is relatively flat and surface drainage has been heavily modified with numerous berms, ditches, and impoundments, particularly on the south side of the fire. The upland areas burned at predominantly low and moderate soil burn severity. Soils are susceptible to wind and water erosion, especially in the northern part of the fire. Erosion rates are anticipated to increase in higher intensity, lower probability rainfall events. Across most of the undeveloped burned area on this fire, runoff potential was already higher than what would be expected under natural conditions due to past land use practices. Fire impacts will likely lead to an increased runoff response above the pre-fire conditions.

Picture 11. Sediment basin in the northern part of the Lahaina Fire (USDA FS)

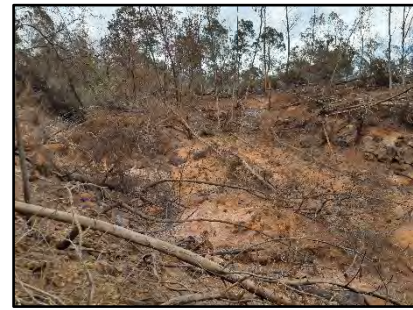
The Kula fire is located at higher elevations, receives higher rainfall at the storm and annual scales, and has steeper slopes relative to most of the other fires apart from Olinda. The larger stream channels are deeply entrenched with unstable gulch walls that exhibited slumping, sliding, and rockfall in pre-fire conditions. Soil burn severity was predominantly low with areas along the gulches found to have moderate and high (15%) SBS. Soils show severe to very severe water and wind erosion hazards. Gulches in the burned area are anticipated to have increases in erosion rates even in smaller, more common runoff events. Elevated post-fire watershed response from the Kula burned area was predicted to be minor at the watershed scale, given the small footprint of the fire. However, higher stream flows in the main channel will entrain ash and fine sediment. The gulch will also contribute woody debris to flood flows, threatening downstream infrastructure.

Picture 13. Moderate and high soil burn severity in a gulch in the Kula Fire.

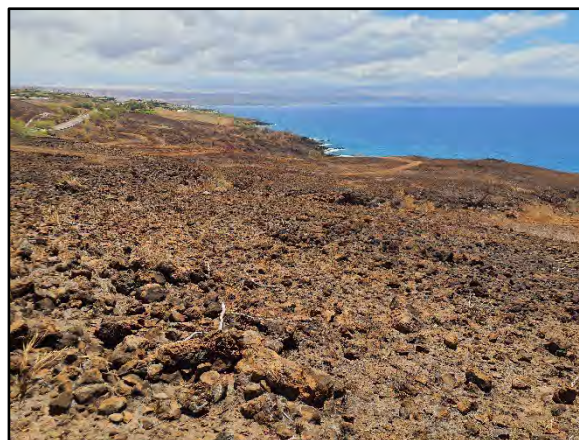
Mauna Kea Beach Resort and Kohala burned areas are on the Kona Coast of Hawaii with relatively low rainfall and relatively low-gradient slopes. Surface-soil rock content is mostly intact in these burned areas. Soil burn severity was predominantly very low and low. The water erosion hazard is moderate for these areas, but the wind erosion hazard is lower-risk due to the high surface-rock content. Like other fires, woody debris, sediment and ash within or near channels can be entrained and transported by stream flow, potentially impacting infrastructure downstream. Channels are entrenched, steep, generally straight and relatively uniform in gradient, so delivery of entrained sediment to the ocean is likely. Localized increases in sediment delivery and runoff are expected, though increases will be minor at the watershed scale due to the relatively small burned areas and low soil burn severity. Some homes below burned hillslopes on the Mauna Kea Fire may be at risk of sediment deposition during heavy rains. In the Kohala fire, some drainages upslope of the highway are unburned or only slightly burned with intact riparian vegetation, whereas riparian areas closer to the ocean saw greater mortality. Grasses are the primary vegetation type across these burned areas, which is expected to recover after the first rainy season.

Picture 15. Low soil burn severity in the Kohala Fire below Highway 270 (USDA FS)

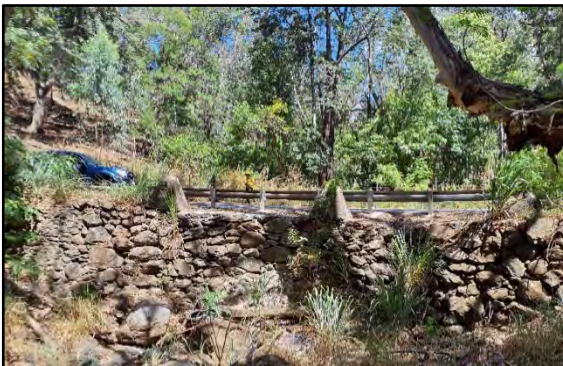
Roads in and downstream of burned areas are at risk of damage due to post-fire conditions. The most likely threat due to the fires is clogging of culverts, bridges, and other in-channel infrastructure from the higher levels of floatable debris (especially burned trees) in burned watersheds. Once blocked by debris, road drainage structures no longer function and the stream flows over the road, often causing considerable damage and limiting access. Debris flows are less likely than debris-laden flood flows, but they pose a greater threat to roads when they do occur and are difficult to mitigate.

Picture 17. Road crossings in the Olinda Fire that would be at risk post-fire (USDA FS)

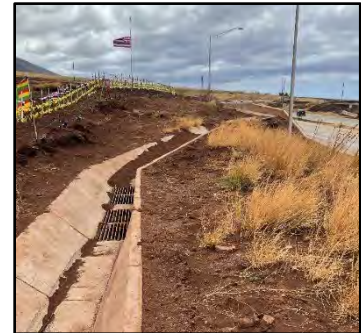
Coral reef and other nearshore habitat is threatened by elevated sediment, ash, and other contaminants from the burned areas. These contaminants include nutrients from burned agricultural and woodlands as well as hazardous materials primarily from developed areas. The primary mechanism of transport to the nearshore environment is in streams draining the burned areas, but wind transport of these materials will also occur. Sediment is derived from soil erosion in the uplands, including the burned areas and unrepaired dozer lines, as well as typical pre-fire sources. However, the amount of additional sediment above background levels that the burned areas will contribute is difficult to predict.

Picture 18. Windblown ash and sediment in a drainage ditch on the Lahaina Fire (USDA FS)

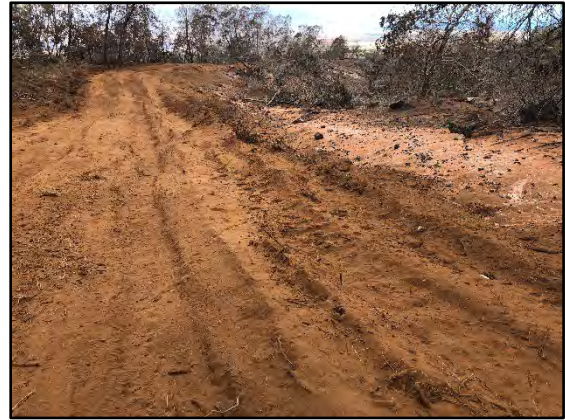
Suppression repair efforts rehabilitate impacts to the landscape, roads, and other resources that occurred during fire suppression activities. During suppression, fire containment lines were constructed near the burned areas with bulldozers. Some of these lines follow the approximate fall-line of the topography and elevated berms remain on both sides of the lines. The BAER Team was not able to observe the total extent of the lines. Additionally, there were no water bars or other erosion control measures evident on the observed lines. These dozer lines are likely to become sources and vectors for eroded sediment because bare soil is exposed, there is considerable slope along some of the lines, and the blade berms will tend to concentrate flows. Without intervention, erosion and sediment delivery to nearby or connected stream channels is likely.

Picture 20. Dozer line on the Kula Fire (USDA FS)
