# Pohakea Watershed Plan

Maui County, HI Final Report January 25<sup>th</sup>, 2023

Hawai'i Office of Planning and Sustainable Development Coastal Zone Management Program

Michael Reyes and Katie Woodbury Maui Environmental Consulting, LLC PO Box 790568 Paia, HI 96779 808-866-6919

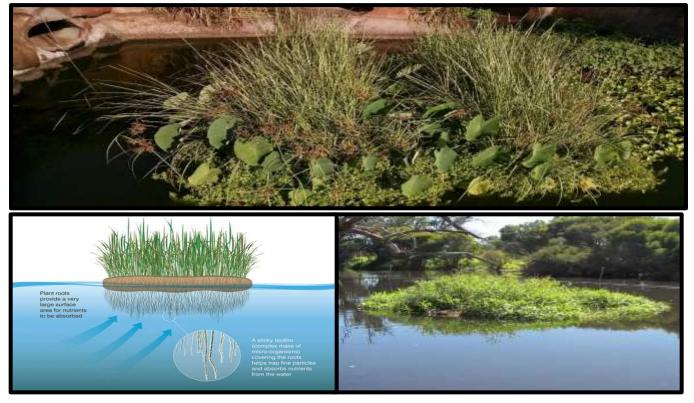
#### Figure 41. Floating Treatment Wetland

Costs vary widely depending upon the overall size and complexity of the floating treatment wetland. Assuming volunteer labor is used to assemble the wetland, a small (8' x 8') version of a floating treatment wetland can be constructed for less than \$1000. Kahili Golf Course greens managers should be partnered with to implement this nutrient reduction strategy. Detailed instructions for creating a FTW can be found at the link below. https://coral.org/wordpress/wp-

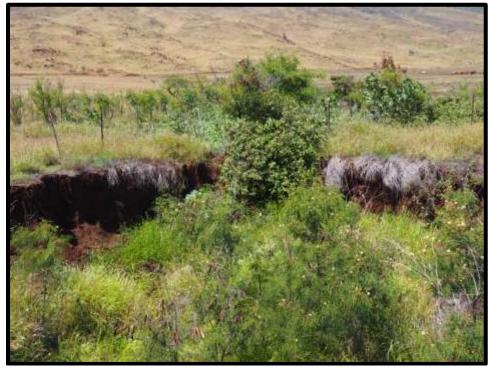
Figure 45. Historic Mā'alaea Gulch Head Cut Monitoring Station – March 2021

Assuming head cut stabilization methods proposed by CDF Engineering in Section 7.2.1 can be implemented to eliminate erosion during storm events, we can assume approximately 70,000 pounds of sediment would be eliminated from entering Mā'alaea Harbor and Mā'alaea Bay each year. These estimates are based on the head cut monitoring that occurred in 2021, when rainfall was just slightly above the five-year average.

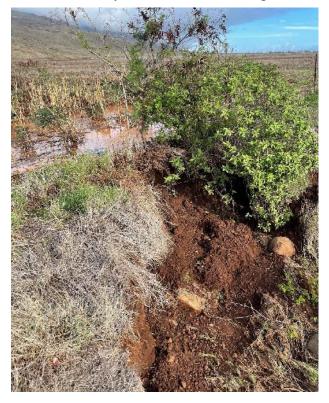
Exposed soil pin at array #9
