Forest Service
U.S. DEPARTMENT OF AGRICULTURE

Pacific Southwest Region | September 2023

**ESF4 Burned Area Emergency Response Assessment
Technical Report
Hawaii Wildfires (CA-FE9-000005)
September 11, 2023**

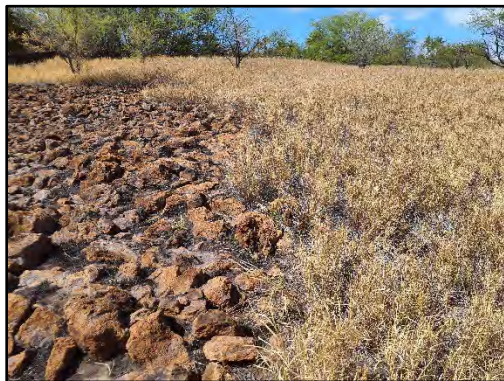
Picture 4. Unburned grass next to low soil burn severity on the Kohala Fire (USDA FS)

Pre-fire vegetation such as grasses or sparse shrubs usually experience extremely rapid consumption and spread rates, with very little heat having residence time at the soil surface (Picture 4, Picture 8). The result is very little alteration of soil organic matter and little or no change in soil structural stability. Water repellency, occasionally present under shrubs before the fire, may or may not be exacerbated by the fire. In the six mapped fires, very low and low soil burn severity was classified in areas where the surface organic material was charred or partly consumed. Roots close to the soil surface were usually still pliable, and soil structure was rarely changed. Most grassland areas burned at very low to low severity; however, low severity was found in all vegetation types. Vegetation recovery is anticipated to be rapid in these areas and sprouting was observed in some grasslands during the assessment. Post-fire erosion response in areas of low soil burn severity will be somewhat variable. Some low severity areas under forest vegetation will have litter and organic material additions before the wet season; however, some of the grasslands have little or no surface cover remaining except rock.

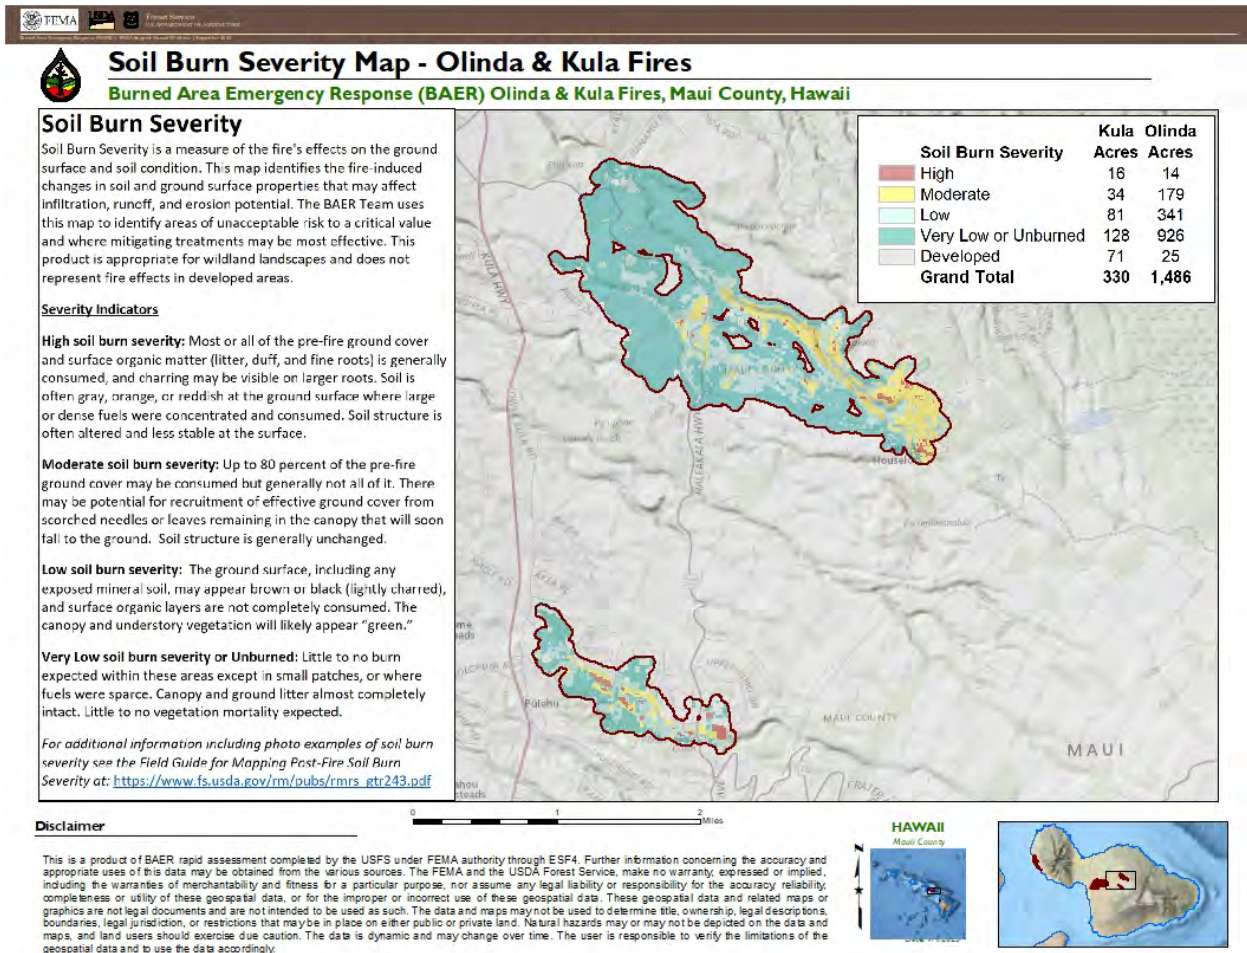
The Soil Burn Severity product is used as an input for all the methods presented in this report; it is the basis for determining the anticipated level of post-fire watershed response. Combined, low (49%) and very low/unburned (34%) soil burn severity cover most of the fire areas with up to 15% moderate and high severity found in the Lahaina and Kula Fires (Table 2). The soil burn severity map for the Olinda and Kula fires is included here and a complete set of map products per fire are found in the Appendices (Figure 2, Appendix A-F. Map Products).

Figure 2. Soil burn severity map for the Olinda and Kula Fires.

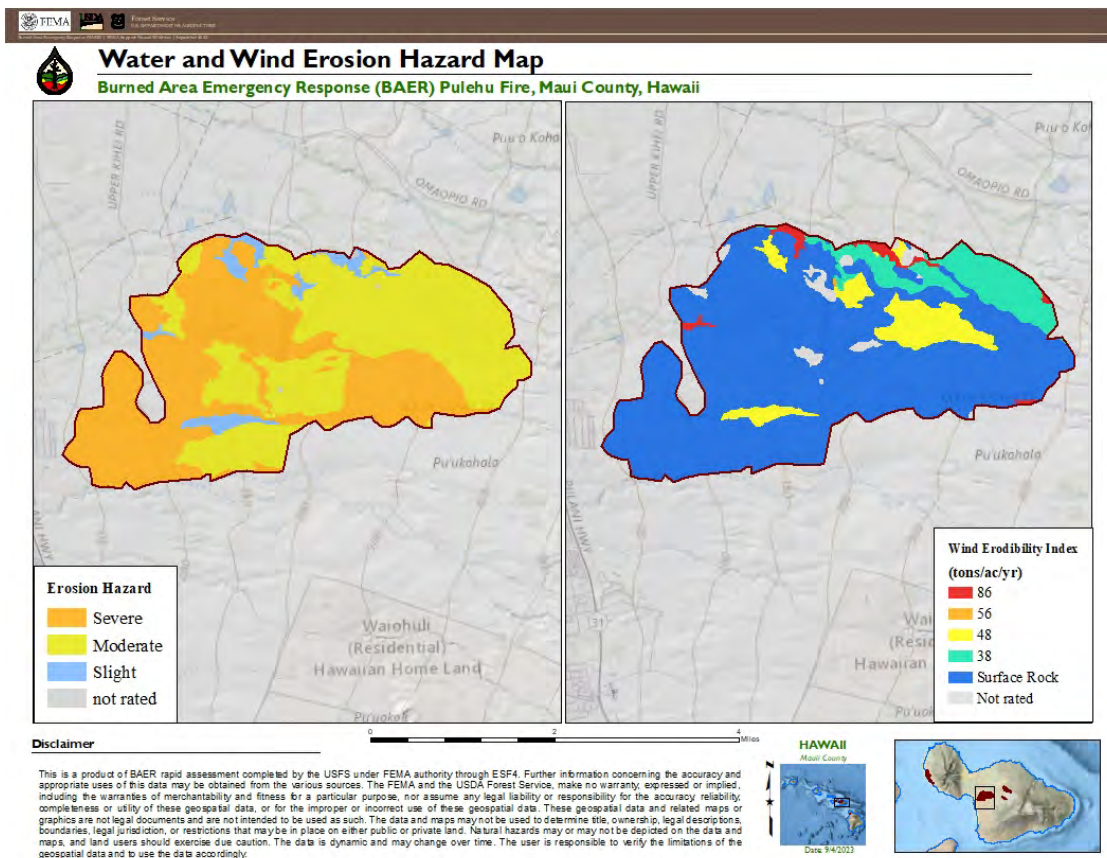
Figure 3. Water and Wind Erosion Hazard Map for the Pulehu Fire.

low wind erosion hazard ratings. Areas where surface rock has been removed to facilitate agricultural production would have an increased erosion hazard over mapping products and thus increased erosion rates over natural conditions (Figure 3).

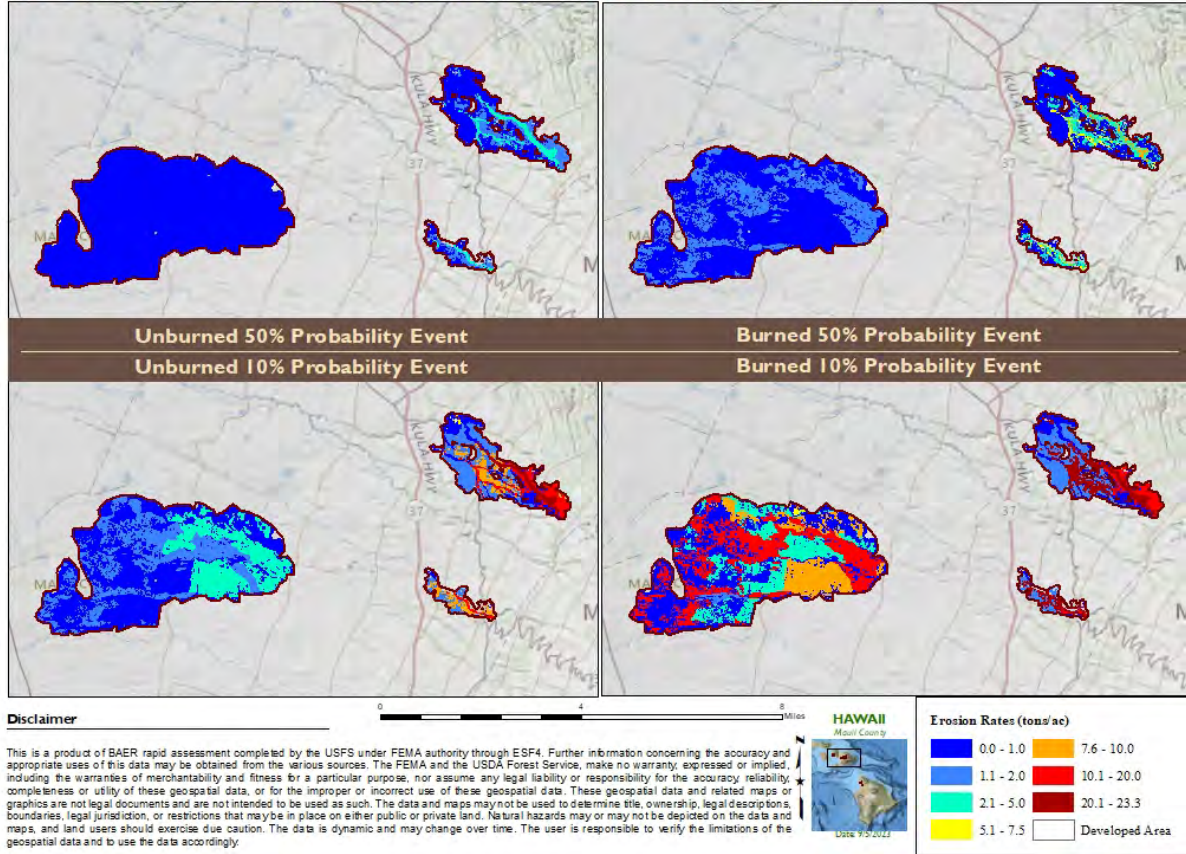
Figure 4. Pre and post-fire erosion rates for the Pulehu, Olinda, and Kula Fires.

These rates and ranges are highly variable across each fire footprint due to differences in slope, soil type, and precipitation across the islands (Figure 4, Appendix A-F. Map Products). Landscape alteration also challenges the ability to predict whether increased erosion will result in additional sediment delivery to stream channels. Constructed berms, sediment basins, and other flow path alterations may result in the deposition of eroded soil on the landscape instead of entering streams and being carried to the ocean, especially from more modest rainstorms.

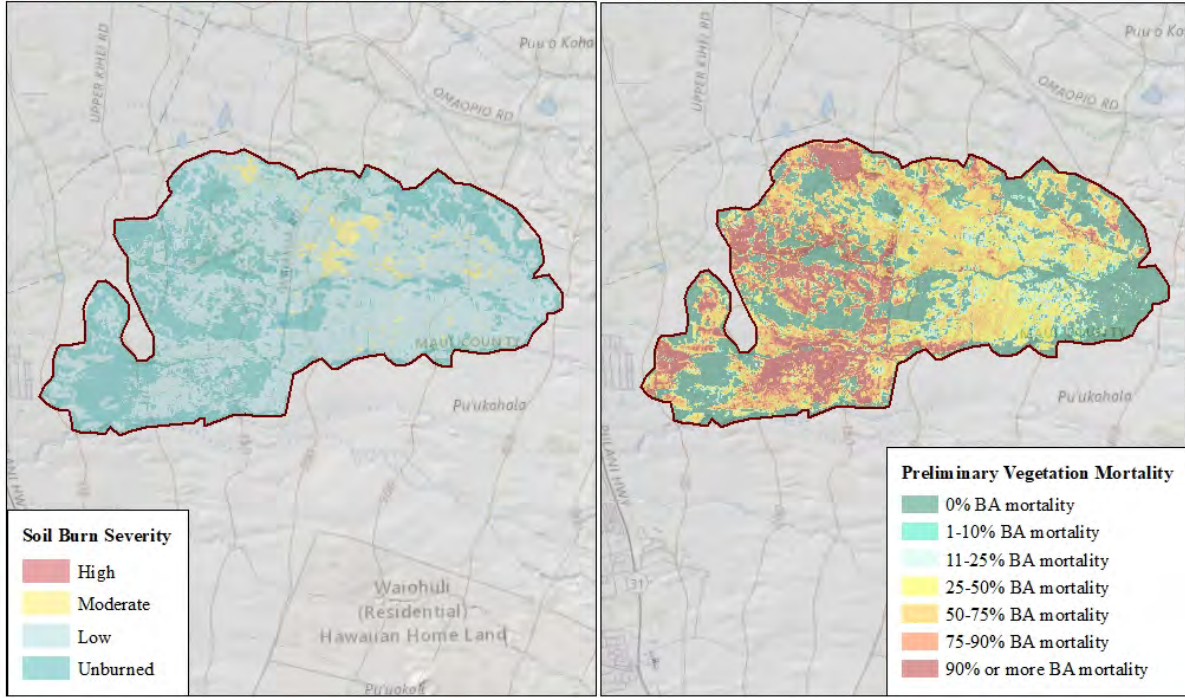
Figure 7. Comparison of Soil Burn Severity to Preliminary Vegetation Mortality for the Pulehu Fire

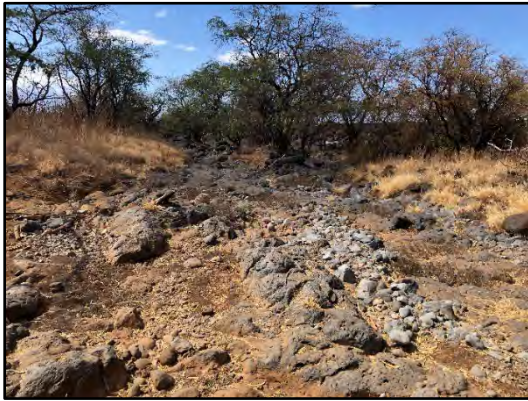
Picture 12. Riparian area in the Pulehu Fire (USDA FS)

due to inherent flood risk, the capacity of the small road bridge near the shore in Kihei was frequently exceeded during even small floods in pre-fire conditions. While post-fire floods are unlikely to be outside the normal range of variability in this stream, the undersized bridge is at a greater risk of plugging due to the potential for higher levels of large woody debris floating downstream from the burned area. Buffel grass (*Cenchrus ciliaris*), the primary vegetation in the fire area, is likely to recover by the end of the next wet season based on observations from similar burned areas. However, non-native axis deer may threaten regrowth and prolong recovery to pre-fire conditions.

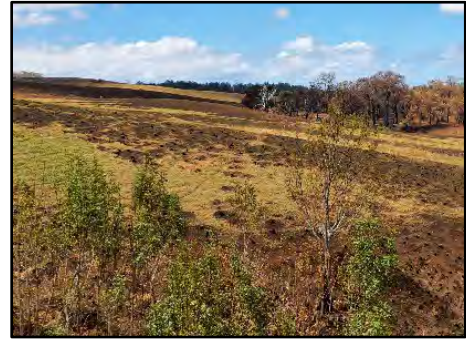
Picture 14. Mosaic patterned burn in the Olinda Fire (USDA FS)

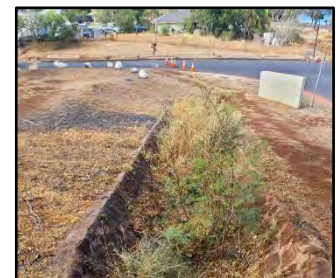
Picture 19. Drainage ditch below the Lahaina Fire that needs cleaning (USDA FS)

Some sediment basins and drainage ditches already exist within the Lahaina fire footprint. Maintain and, if needed, clean out debris that is deposited in these structures and ensure culvert outlets are kept clear of debris to ensure the free flow of water. Ensure channels and flow paths leading to sediment basins are functioning as intended, and water flow is not diverted out of the designed systems. Consider larger settling basins if an engineering analysis demonstrates their cost-effectiveness, suitable sites exist, and a longer-term source of funding is identified for maintenance.

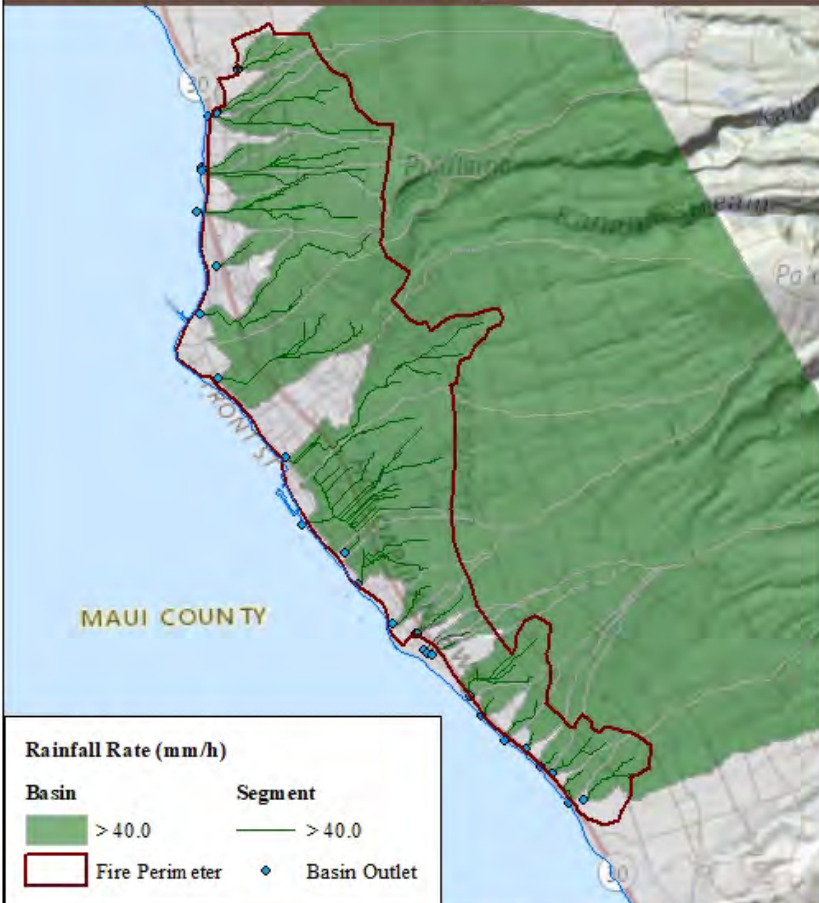
Year 1 Rainfall Thresholds

Rainfall rates that have a 50% likelihood of triggering debris flows

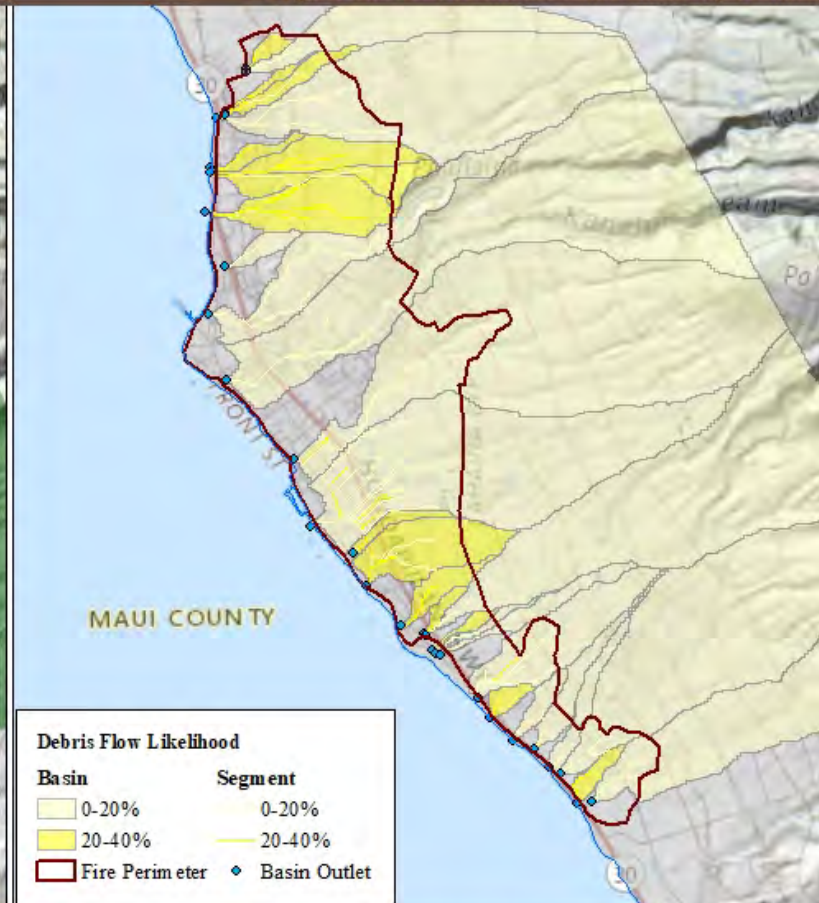
Debris-flow Likelihood

Design storm: Peak 15-minute rainfall intensity 40 mm/h

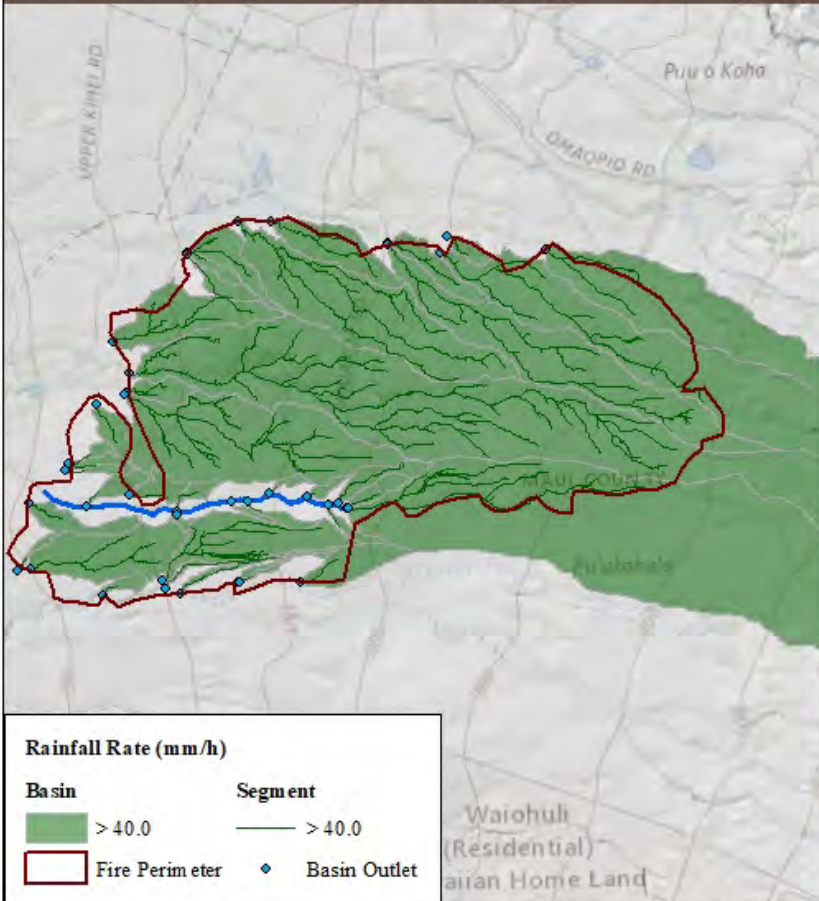
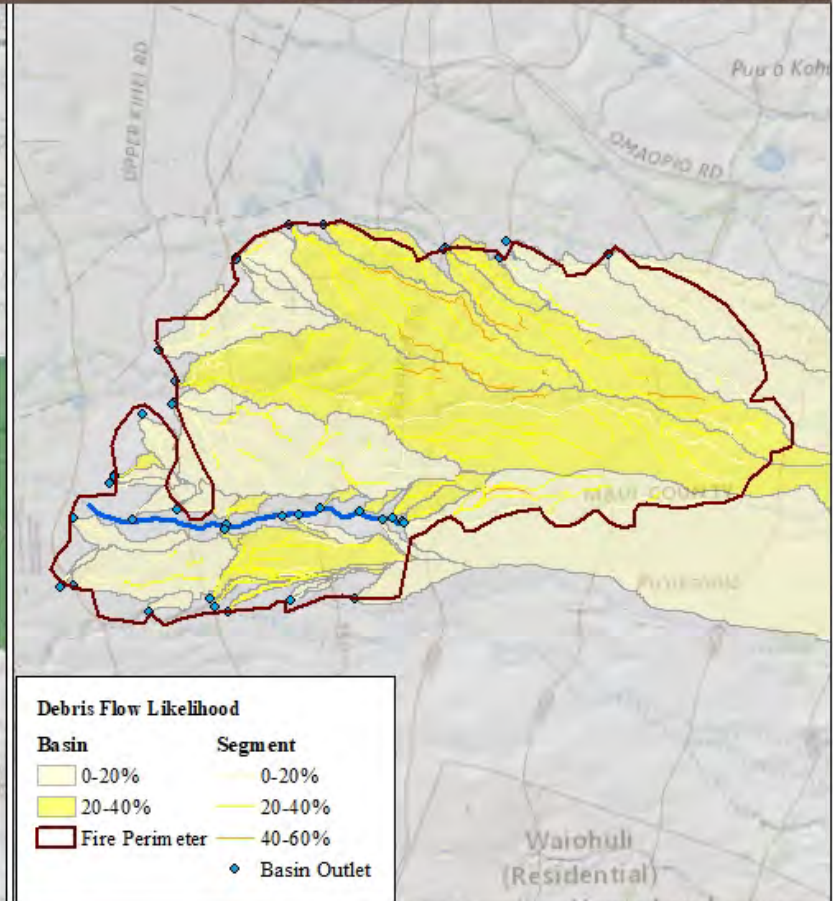
USGS Debris Flow Hazard Assessment

Rainfall rates that have a 50% likelihood of triggering debris flows

Debris-flow Likelihood
 Design storm: Peak 15-minute rainfall intensity 40 mm/h

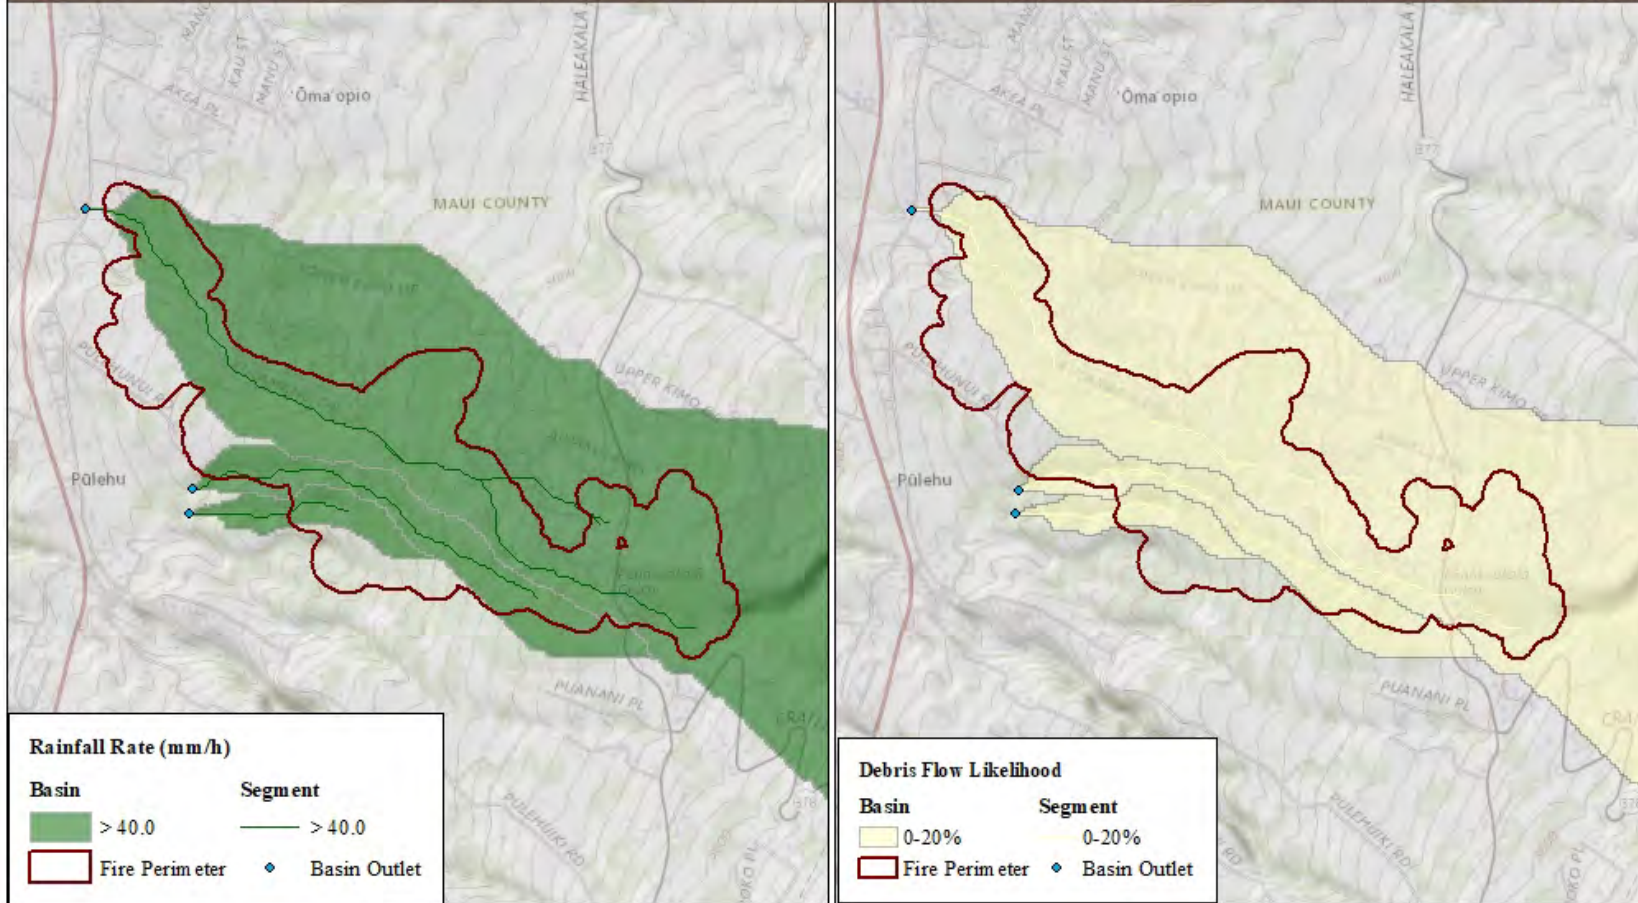
Debris-flow Likelihood

Design storm: Peak 15-minute rainfall intensity 40 mm/h

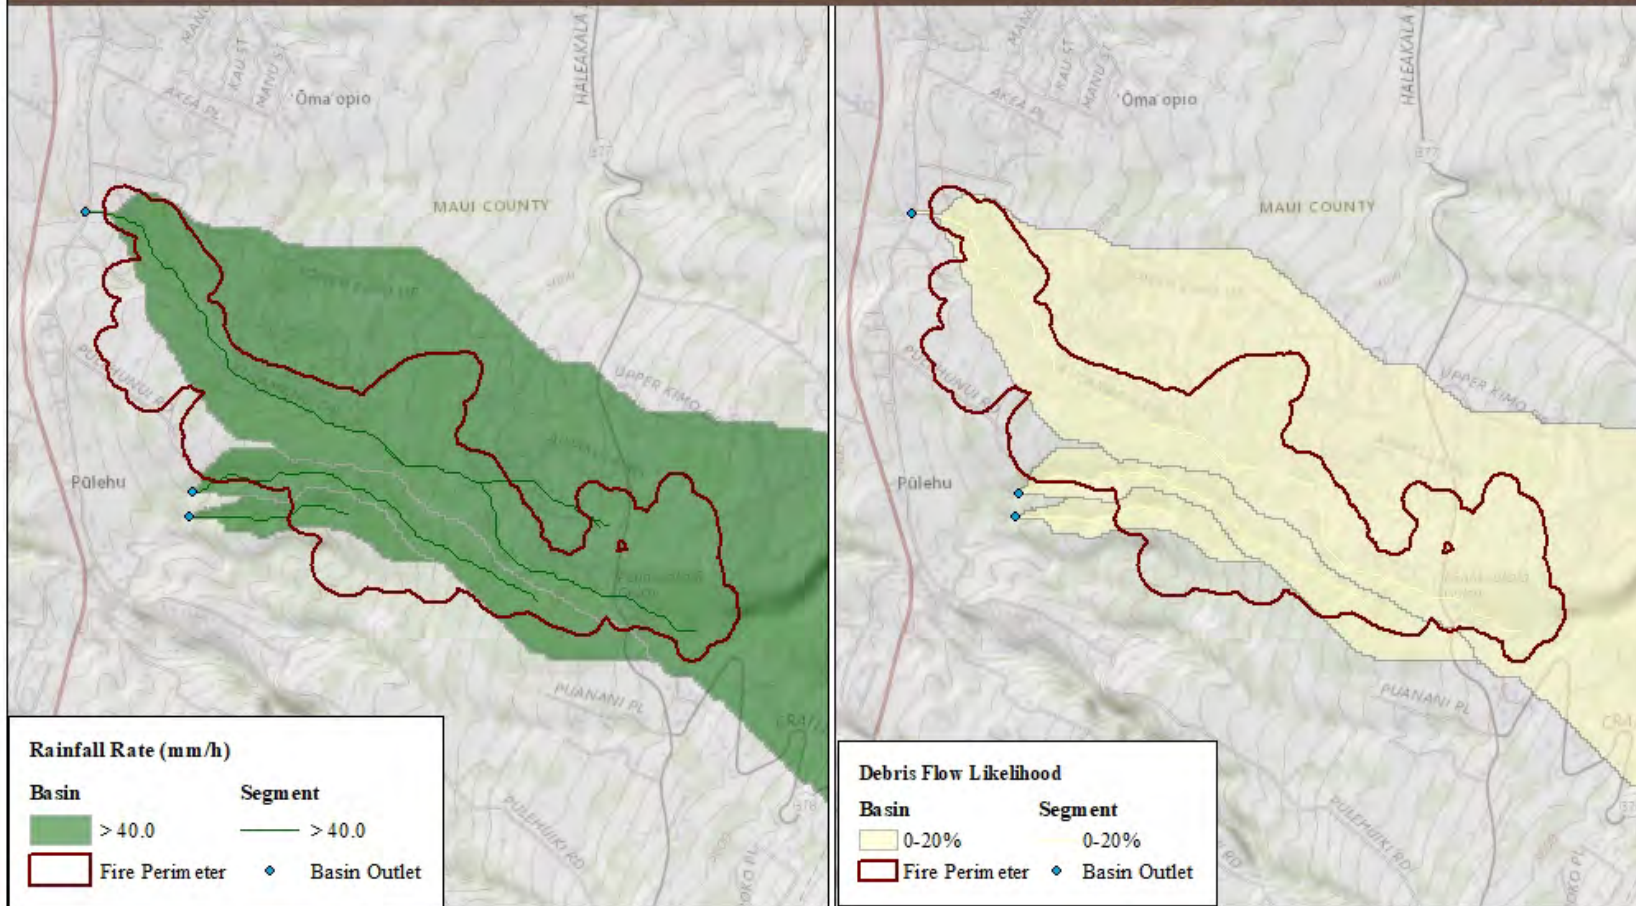
USGS Debris Flow Hazard Assessment

Design storm: Peak 15-minute rainfall intensity 40 mm/h

Debris Flow Likelihood	
Basin	Segment
 0-20%	 0-20%
 Fire Perimeter	 Basin Outlet

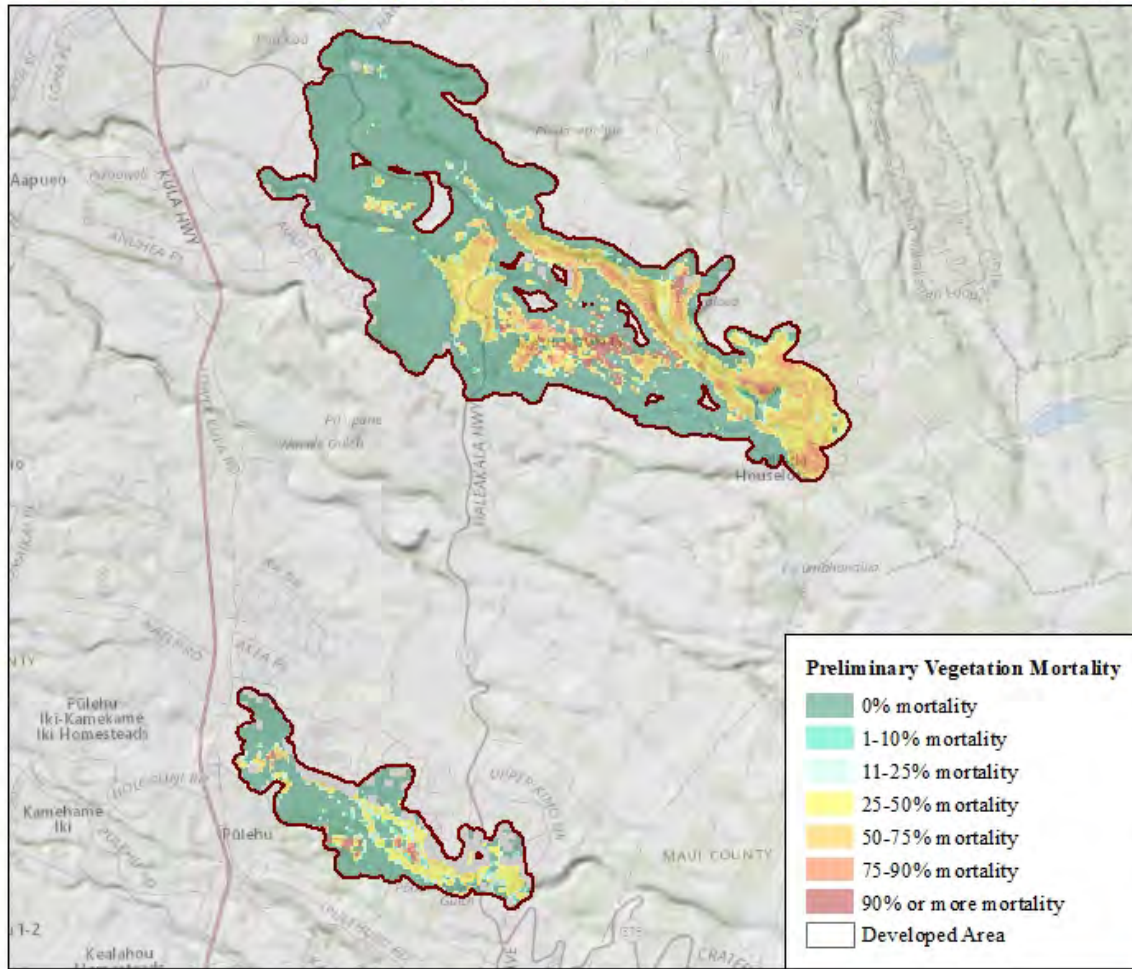
Preliminary Vegetation Mortality - Olinda & Kula Fires

This is a post-fire preliminary vegetation mortality product that focuses on the current wildfire effects to the forest vegetation and is reported in percent of live vegetation loss. This product was derived from satellite image classification, using Google Earth Engine (GEE) to provide image collections and derive cloud-free pre and post fire images over the fire area. This product helps BAER team scientists understand the scope and scale of vegetation mortality in assessing emergency response strategies.

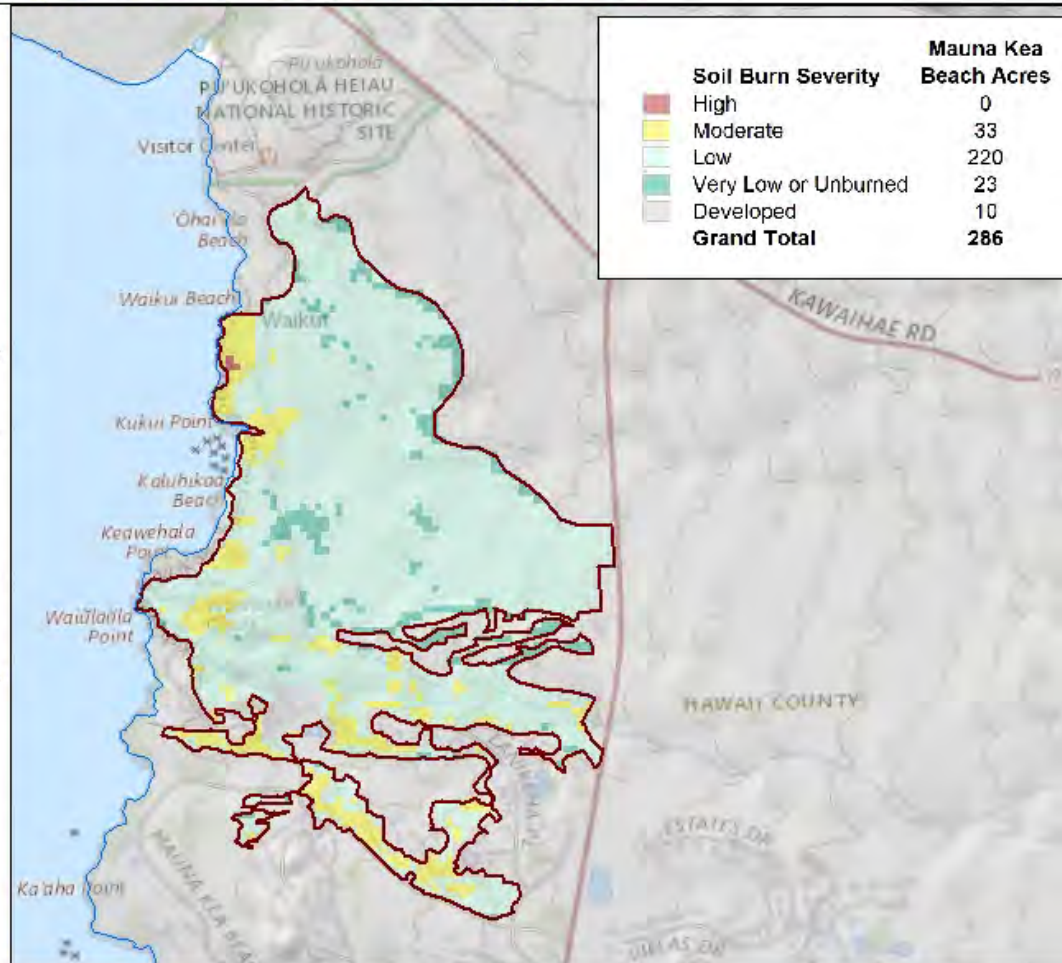
Soil Burn Severity Map - Mauna Kea Beach Fire

Soil Burn Severity is a measure of the fire's effects on the ground surface and soil condition. This map identifies the fire-induced changes in soil and ground surface properties that may affect infiltration, runoff, and erosion potential. The BAER Team uses this map to identify areas of unacceptable risk to a critical value and where mitigating treatments may be most effective. This product is appropriate for wildland landscapes and does not represent fire effects in developed areas.

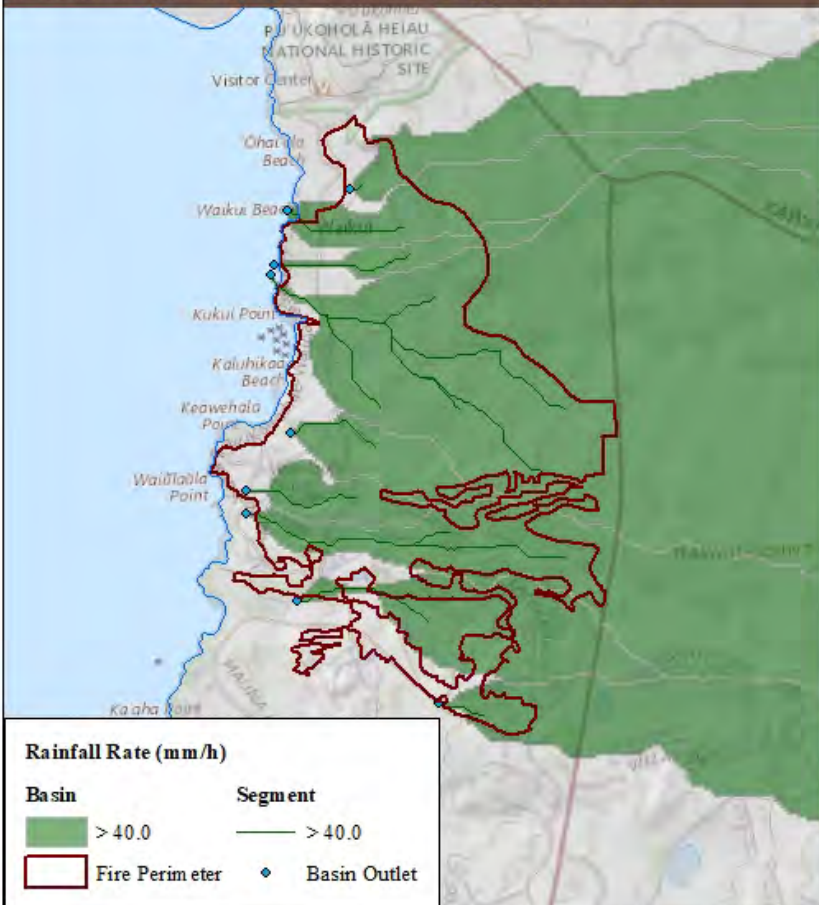
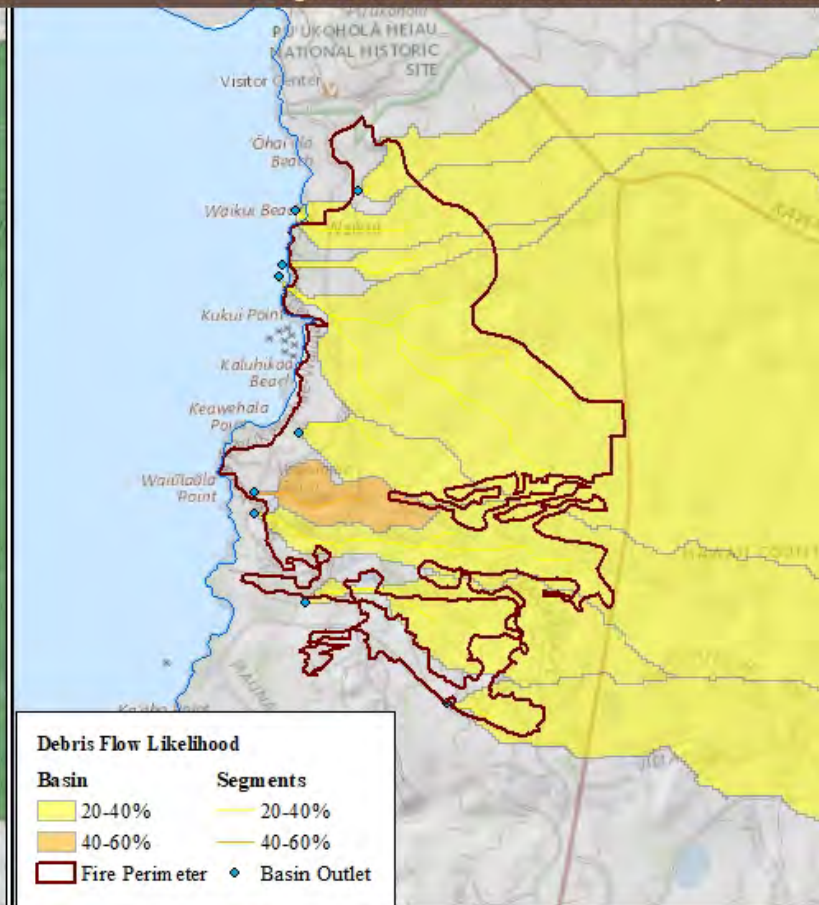
USGS Debris Flow Hazard Assessment

Rainfall rates that have a 50% likelihood of triggering debris flows

Design storm: Peak 15-minute rainfall intensity 40 mm/h

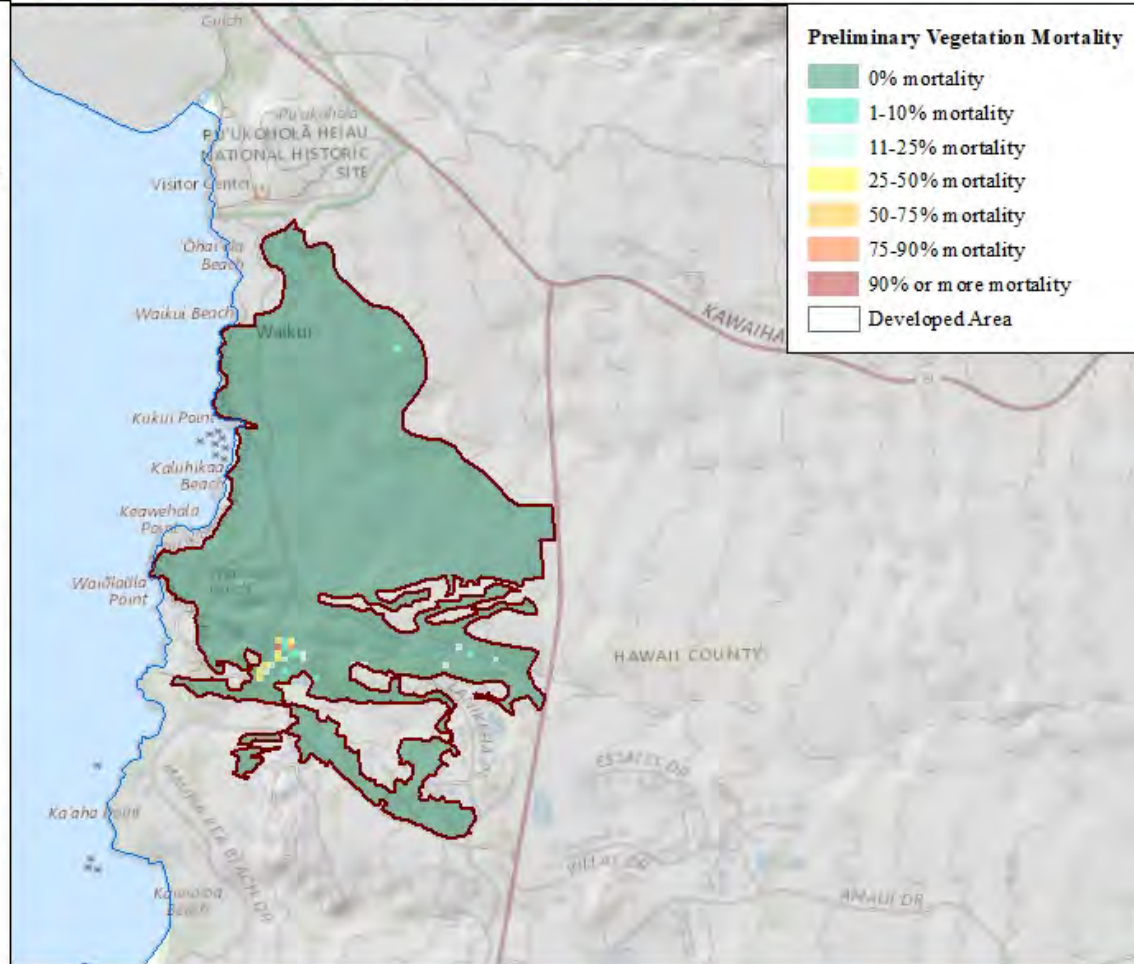
Burned Area Emergency Response (BAER) Mauna Kea Beach Fire, Hawaii County, Hawaii

The BAER Team uses this Vegetation Mortality product to compare with Soil Burn Severity to illustrate the difference between the effect of the fire on vegetation vs the effect of the fire on the soil. This vegetation mortality has not been field verified. The classification method used to generate the Vegetation Mortality product was developed for a forested environment and may not be accurate outside that environment. Many other factors can affect the accuracy of an image classification, including regrowth of grasses post-fire and wind erosion removing sediment and ash deposits. This product has not been field verified.

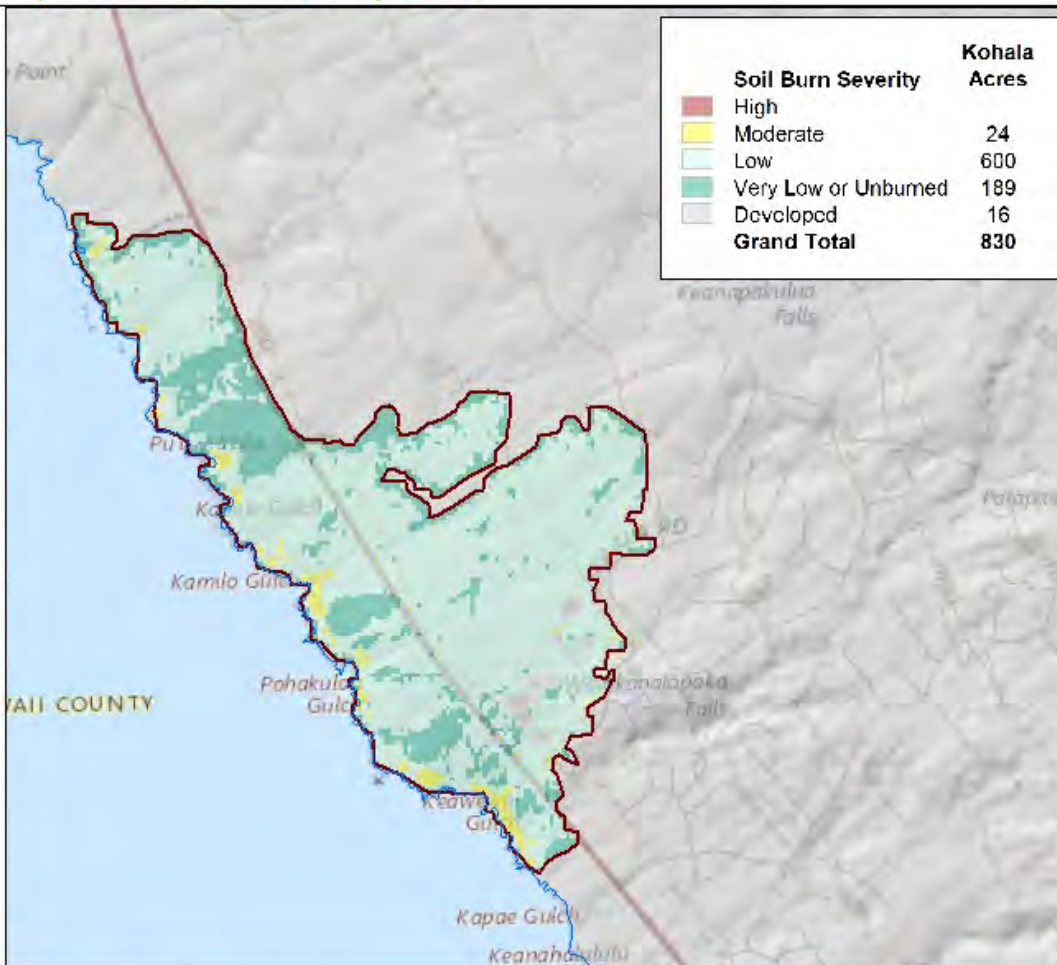
Soil Burn Severity Map - Kohala Fire

Soil Burn Severity is a measure of the fire's effects on the ground surface and soil condition. This map identifies the fire-induced changes in soil and ground surface properties that may affect infiltration, runoff, and erosion potential. The BAER Team uses this map to identify areas of unacceptable risk to a critical value and where mitigating treatments may be most effective. This product is appropriate for wildland landscapes and does not represent fire effects in developed areas.

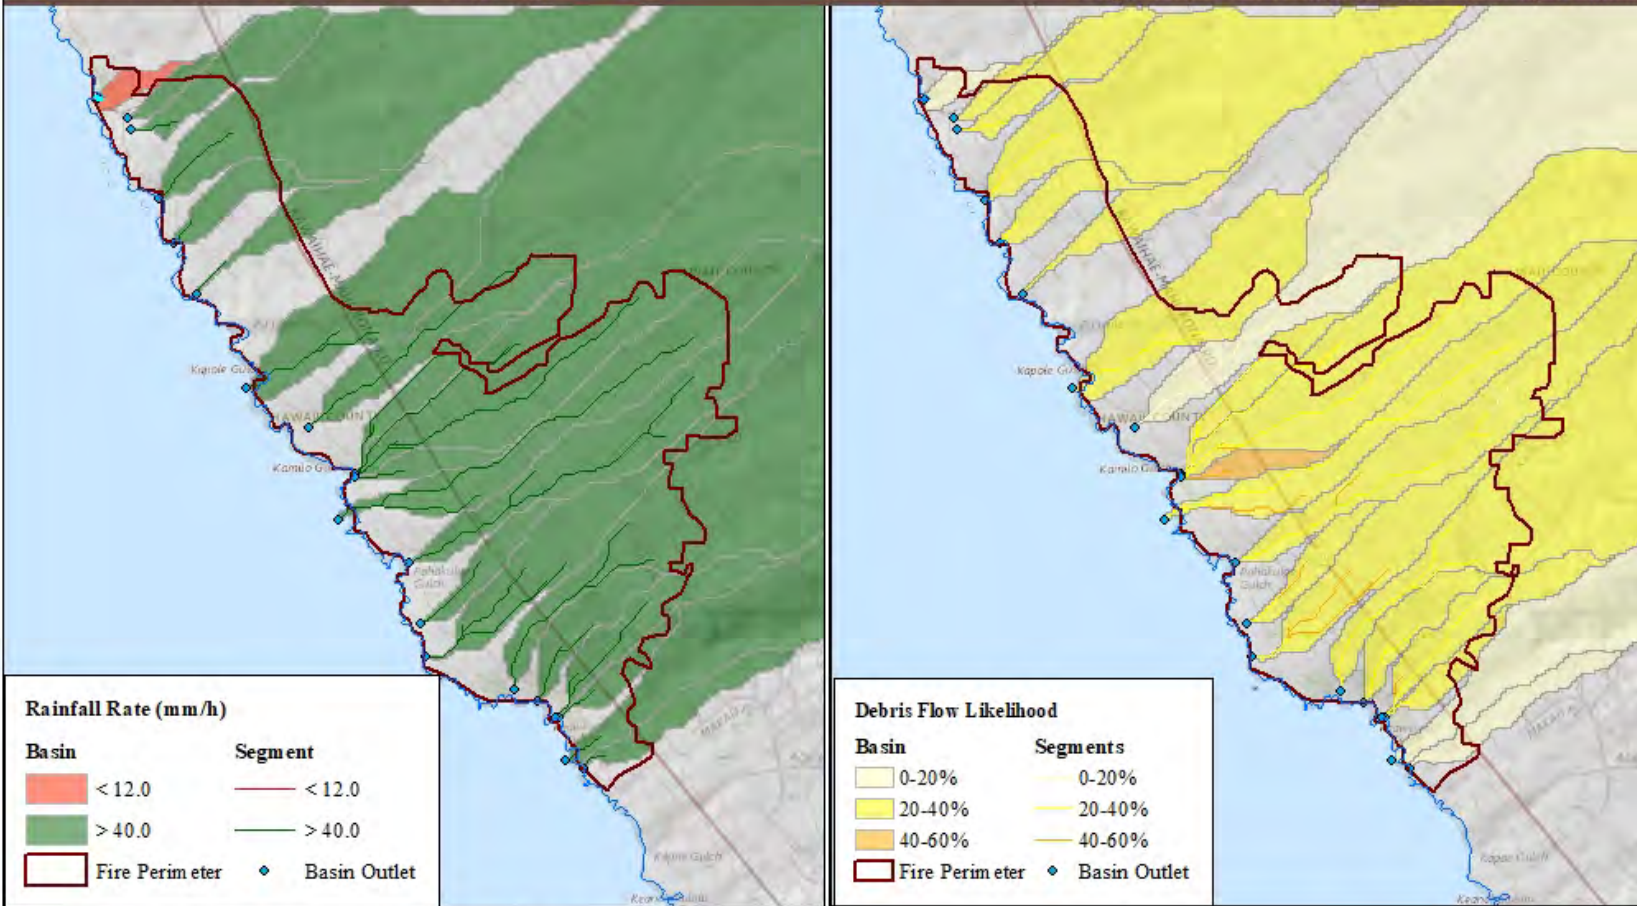
USGS Debris Flow Hazard Assessment

Rainfall rates that have a 50% likelihood of triggering debris flows

Design storm: Peak 15-minute rainfall intensity 40 mm/h
 Debris-flow Likelihood

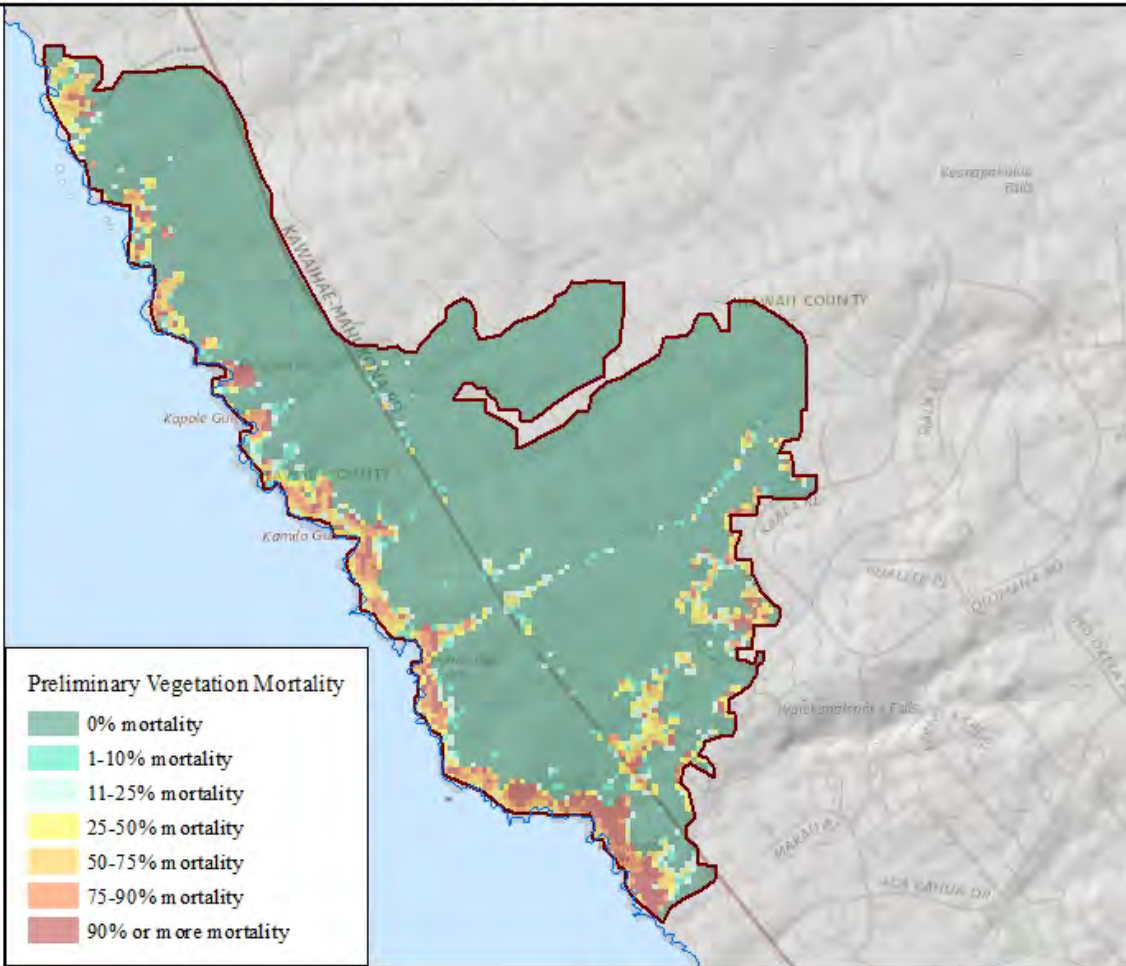
Preliminary Vegetation Mortality - Kohala

The BAER Team uses this Vegetation Mortality product to compare with Soil Burn Severity to illustrate the difference between the effect of the fire on vegetation vs the effect of the fire on the soil. This vegetation mortality has not been field verified. The classification method used to generate the Vegetation Mortality product was developed for a forested environment and may not be accurate outside that environment. Many other factors can affect the accuracy of an image classification, including regrowth of grasses post-fire and wind erosion removing sediment and ash deposits. This product has not been field verified.
